Inspection Report

Property Address:
411 Marie Court
Merced CA

Great West Inspection

Date: 8/18/2009	Time:	Report ID: 812809-01JM
Property: 411 Marie Court Merced CA	Customer: Sherry Flanders	Real Estate Professional: Lupita Sanchez M&M Century 21

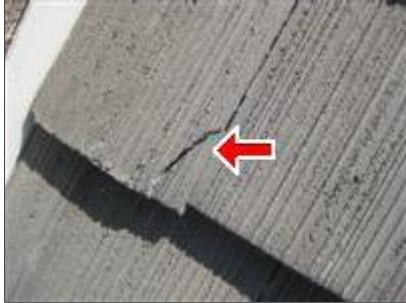
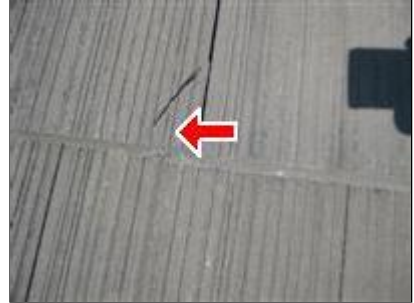
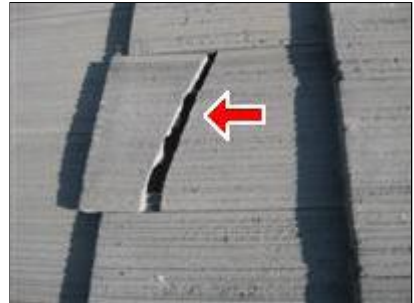
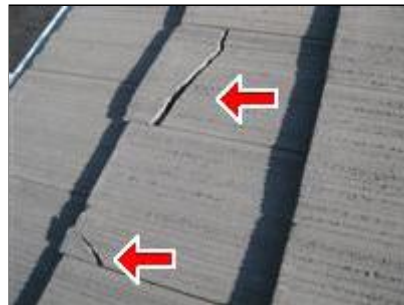
At least five or more tiles are cracked and will need repairs. P8 remove loose tiles on the east side. When inspecting the roof we are looking for displaced roofing tiles and also checking the vent stacks and valleys for obstructions. We also check the interior space of the attic for any active water staining from possible leaks at the various points inside the attic. Tile roofs are highly resistant to wear and have a life expectancy of fifty plus years. However, problems can develop and these problems need attention in order to prevent leakage. We look for cracked and missing tiles and cracked and deteriorated tile mortar joints. We also examine the visually accessible connection and penetration flashings for damage and defects. Problems in these areas create opportunities for leakage and must be corrected to prevent moisture penetration. The water tightness of a tile roof depends to a large degree on the condition of the felt underlayment. All cracked tiles should be inspected and repairs as needed by a licensed roofing contractor.

1. At least five or more tiles are cracked and will need repairs. P8 remove loose tiles on the east side. When inspecting the roof we are looking for displaced roofing tiles and also checking the vent stacks and valleys for obstructions. We also check the interior space of the attic for any active water staining from possible leaks at the various points inside the attic.
Tile roofs are highly resistant to wear and have a life expectancy of fifty plus years. However, problems can develop and these problems need attention in order to prevent leakage. We look for cracked and missing tiles and cracked and deteriorated tile mortar joints. We also examine the visually accessible connection and penetration flashings for damage and defects. Problems in these areas create opportunities for leakage and must be corrected to prevent moisture penetration. The water tightness of a tile roof depends to a large degree on the condition of the felt underlayment. All cracked tiles should be inspected and repairs as needed by a licensed roofing contractor.

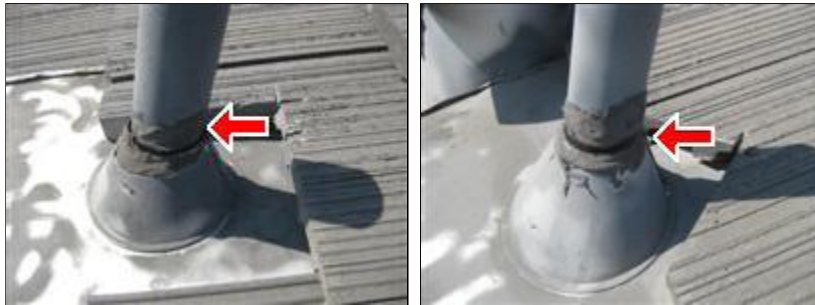
1.5 Picture 1

Plumbing vent pipes need caulking around perimeter of pipe and boot where boot flange has failed.

2. Plumbing vent pipes need caulking around perimeter of pipe and boot where boot flange has failed.

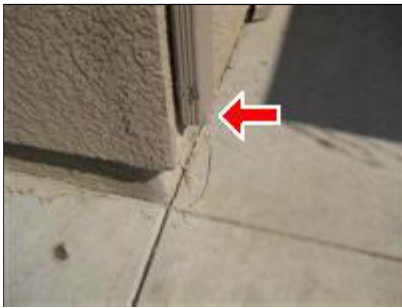
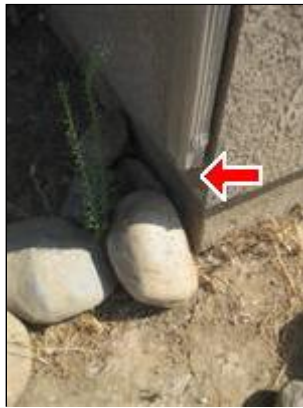
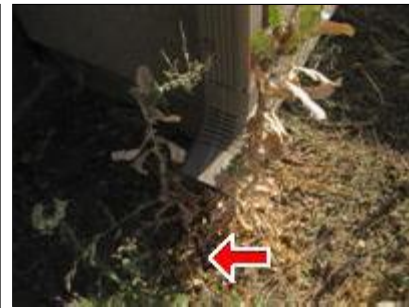
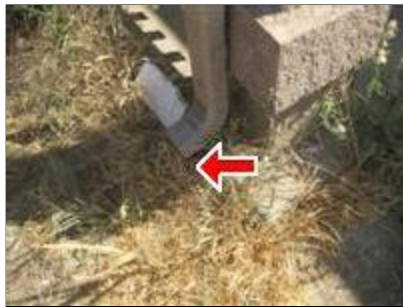
P 1, 2 Drain line near the patio should have a 45 degree elbow installed to prevent water from backing up under the foundation at this area.

INADEQUATE FOUNDATION DRAINAGE - Continuous foundation area moisture accumulation causes damage and/or deterioration to the foundation and/or framing. We recommend that the drainage be upgraded as necessary to collect the surface and subsurface moisture approaching the foundation and route it to some central drainage collection point. All damaged foundation and framing should be repaired or replaced as necessary.

ROUTE DOWNSPOUTS - All downspouts that do not terminate within drain lines should be routed sufficiently away from the foundation to prevent puddling and pooling and subsequent seepage through the foundation and into the basement, garage and/or subarea.

3. P 1, 2 Drain line near the patio should have a 45 degree elbow installed to prevent water from backing up under the foundation at this area.

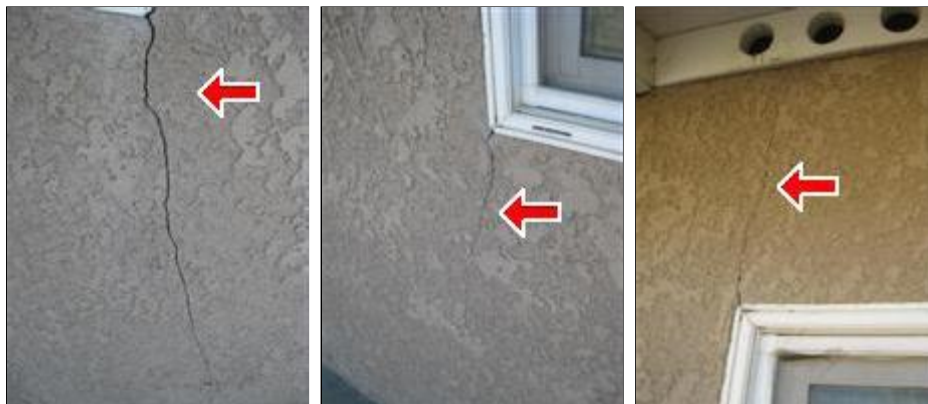
2.5 Picture 1

Stucco is a rigid material that can crack as a result of slight movement of a house, settlement of foundation, or improper application. Cracks over 1/16th of an inch should be sealed with a coating patch material. Stucco does not require paint. Pictures show signs of settlement cracking.

West exterior wall. Seal all chips and holes with stucco patching to prevent water penetration to the interior sheathing or walls.

4. Stucco is a rigid material that can crack as a result of slight movement of a house, settlement of foundation, or improper application. Cracks over 1/16th of an inch should be sealed with a coating patch material. Stucco does not require paint. Pictures show signs of settlement cracking.

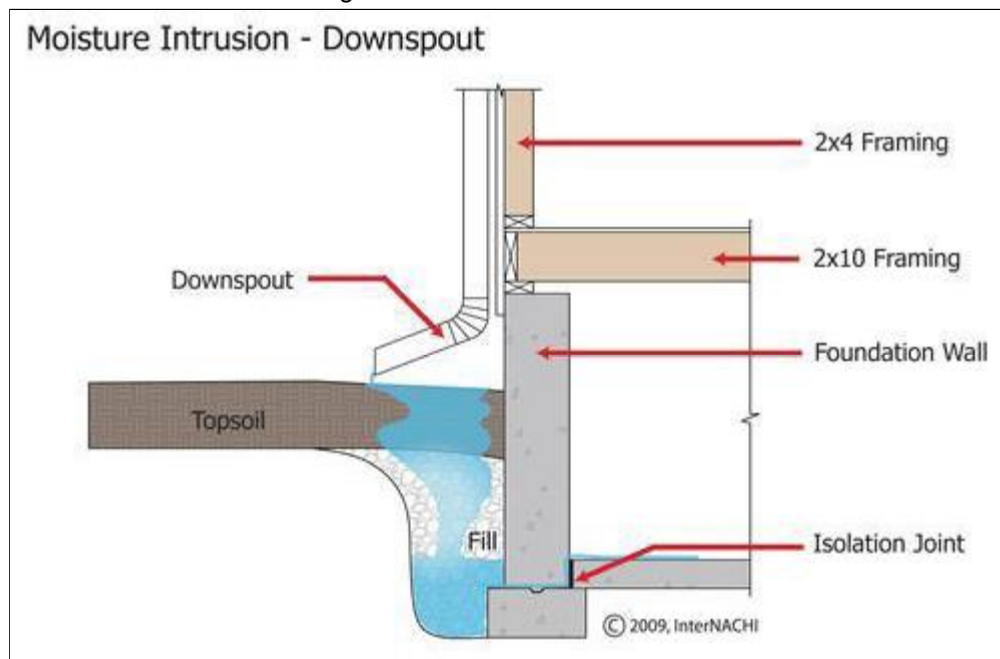
3.1 Picture 1

Two downspouts on the east side need 45 degree elbows and drain line extensions.

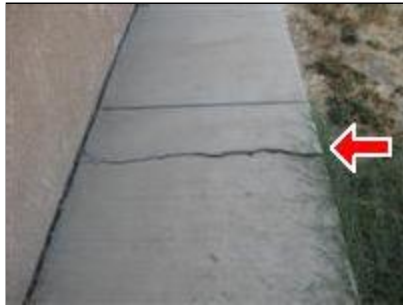
3.7 Picture 1

Typical settlement cracks on sidewalk. West side.

Minor cracks, settlement, heaving and/or deterioration were found in one or more sidewalk or patio sections. However, they don't appear to be a structural concern and no trip hazards were found. No immediate action is recommended, but the client may wish to have repairs made or have cracked sections replaced for aesthetic reasons.

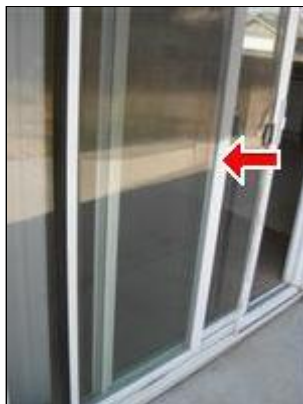
4.4 Picture 1

Screen is torn or loose on rear patio sliding door. South side.

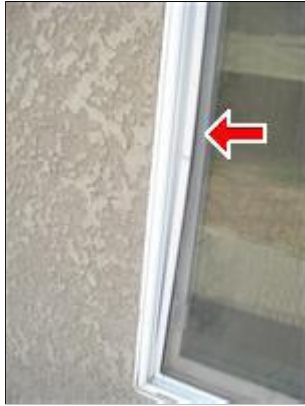
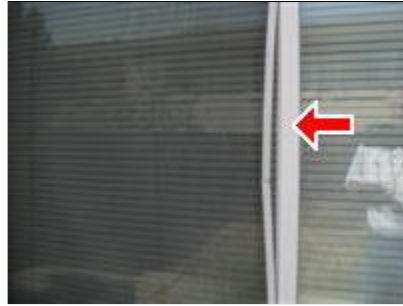
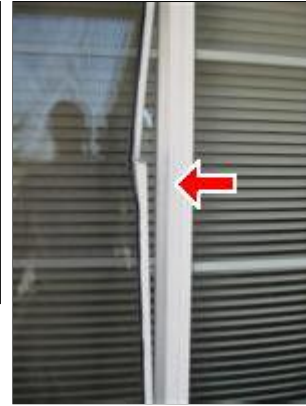
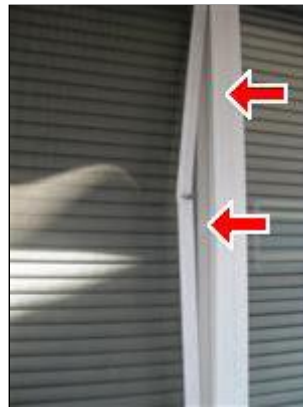
The window screen frames are damaged. At several locations. East exterior wall. West exterior wall.

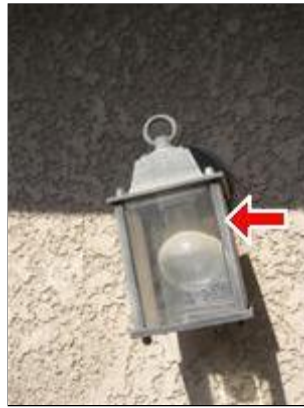
4.21 Picture 1

Light at garage east wall is mounted side ways.

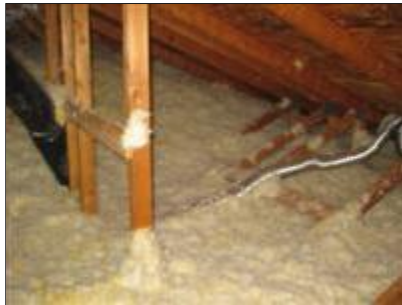
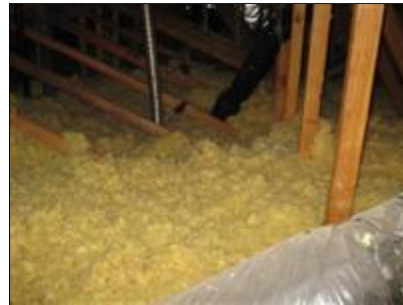
The ceiling insulation in some areas of the attic was uneven. This may result in increased heating or cooling costs due to decreased energy efficiency. A qualified person should repair, replace or install insulation as necessary.

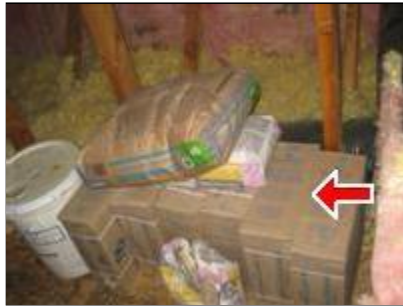
5.9 Picture 1

Items stored near the furnace are combustible and too heavy for the attic truss, remove as needed.

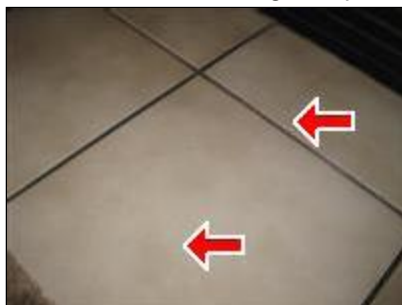
5.12 Picture 1

The floor tile is cracked in front of the fireplace. Cosmetic cracking. Fireplace clean out trap door does not latch closed.

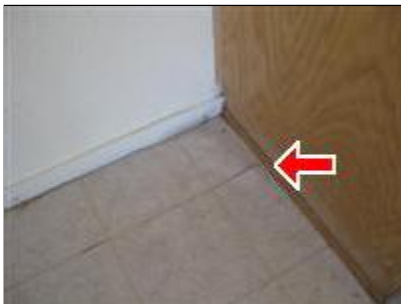
6.3 Picture 1

Vinyl is curling around edges and needs securing with adhesive and, or shoemold near the refrigerator area. Vinyl flooring was deteriorated in some (kitchen) areas. A qualified person should repair or replace as necessary.

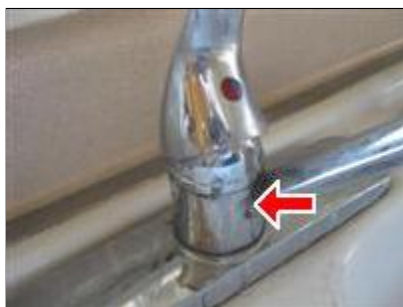
7.3 Picture 1

- 🏠 Repairs needed at the lever on faucet leaks at the kitchen sink. Leaking at faucet body.

Repairs needed at the lever on faucet leaks at the kitchen sink. Repairs are needed to stop leaking water from further damaging the cabinet bottom or to eliminate moisture that may contribute to fungi growth. I recommend repair as necessary by a qualified person.

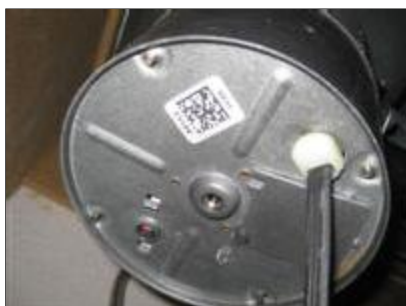
7.4 Picture 1

- 🏠 Disposer would not operate. Non functional. The motor was frozen, power to the unit appears to be operational but the motor appears jammed. The disposer system or component which no longer functions as designed and intended.

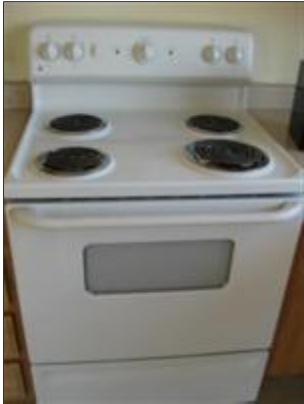
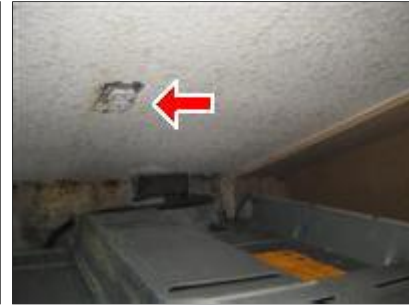
- 🏠 P3 The coverplate is missing behind the stove.

Safety Alert: There did not appear to be an anti tip bracket or device installed on the oven/stove. This is a safety/burn hazard. This prevents a child from tipping over the stove by opening the oven door and standing on it or using it as a step while something is being cooked on the stove. We recommend a anti tip bracket be installed.

UNDERSIZED GAS CONNECTOR - We found an undersized gas connector at the oven appliance. The diameter of the gas supply piping should be no smaller than the inlet connection of the appliance. We recommend that the connector be removed and an approved connector installed in accordance with standard building practice.

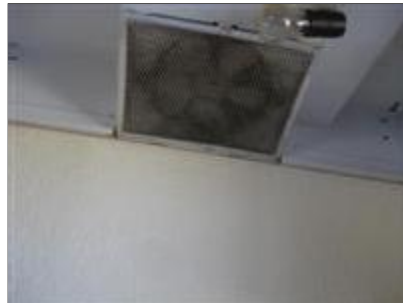
7.6 Picture 1

The grease screen is dirty. The interior panel or cover is missing at the cabinet over the ventilation unit. A replacement cover should be installed.

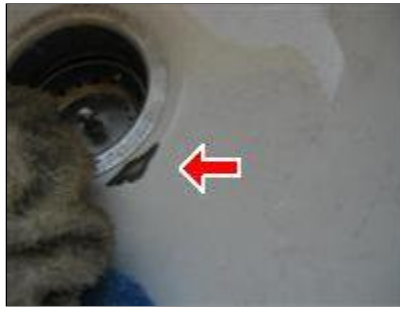
7.11 Picture 1

- 🏠 Sink has some chipping on porcelain finish. Caulk or grout the outer edge of the sink where it meets the tile countertop.

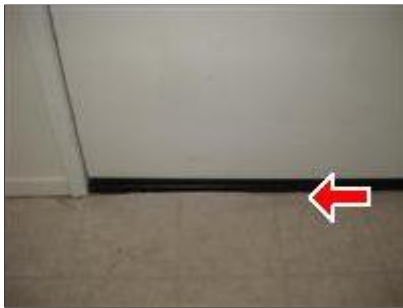
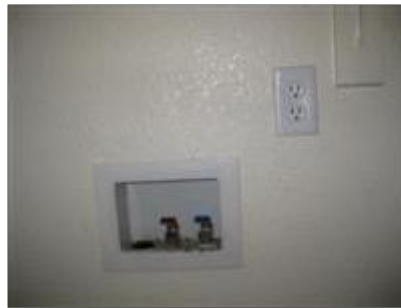
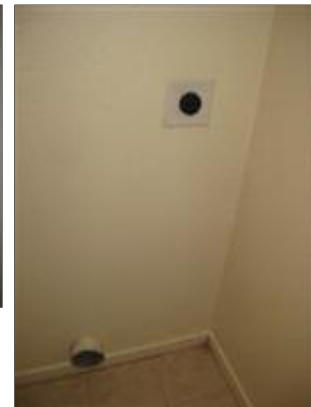
- 🏠 P1 the vinyl floor is curling near the garage entrance at the laundry floor. The 220 electric coverplate for the dryer is damaged and needs repairs.

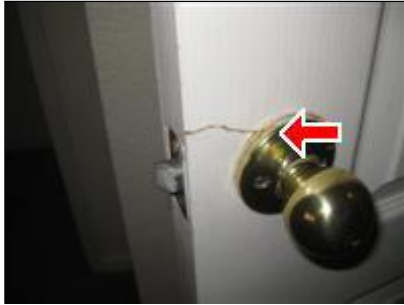
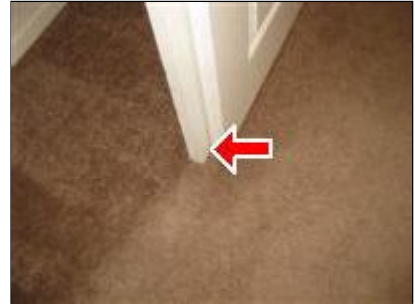
P1 the door at the east side bedroom has damage near the latch. P2-4 Bedroom sliding closet doors should have lower floor track installed for safety.

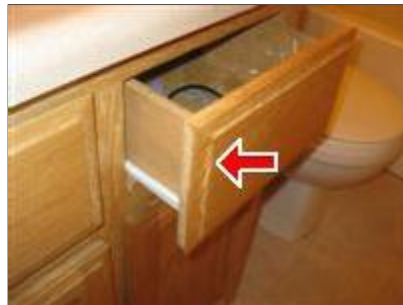
9.1 Picture 1

P1 the hall bath vanity drawer right of the sink slides hard on the track and should be adjusted.

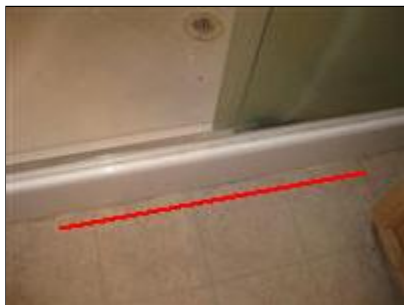
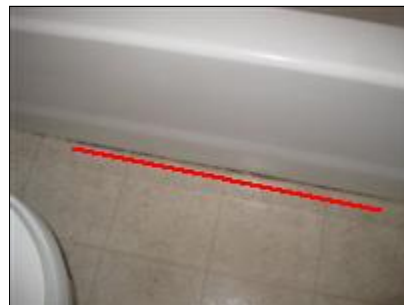
Recommend silicone caulk along floor and tub at Hall Bath, Master Bath. We recommend caulking at the base valve covers.

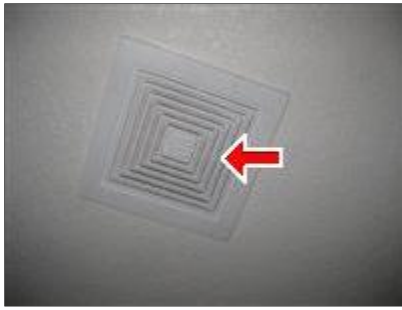
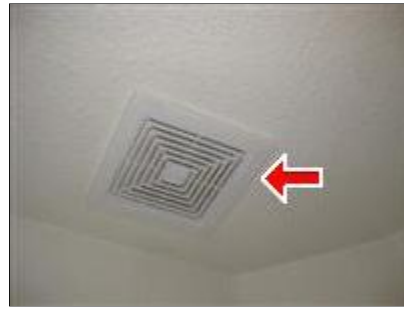
Clean the fans at both bathrooms/.

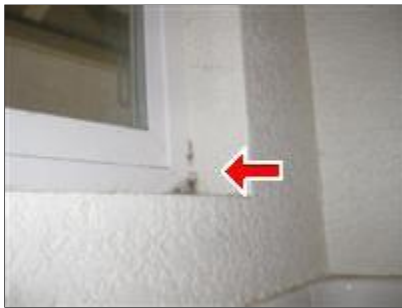
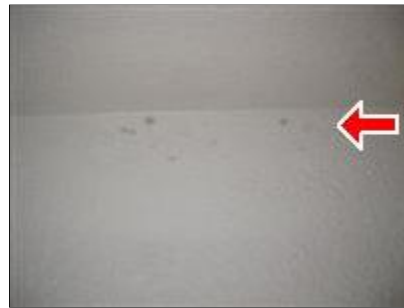
East wall, South wall.

Water stains noted at the window and wall of the master bathroom.

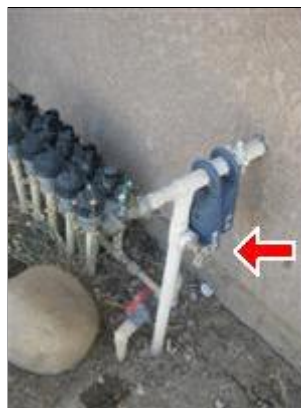
10.6 Picture 1

The main shut-off is the handle located on the front wall.

West side.

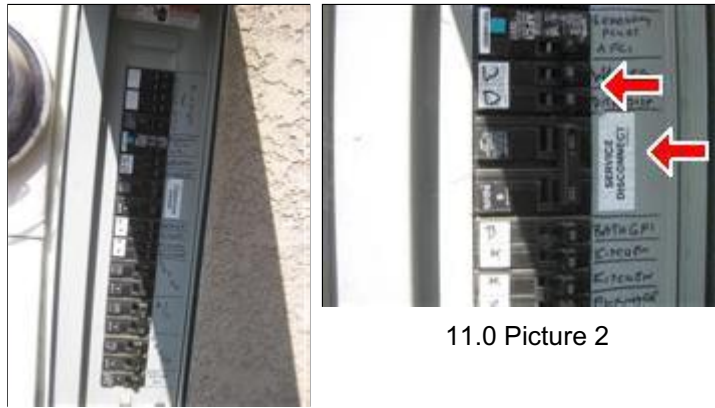
11.0 Picture 1

Electric Service Panel Shut Off View

P2 BREAKER BRIDGE MISSING - A 240 volt double pole breaker installed without a bridge between the two pole handles. We recommend that this breaker be bridged. This will insure that all of the power is shut off to this circuit if the overcurrent protection device is tripped.

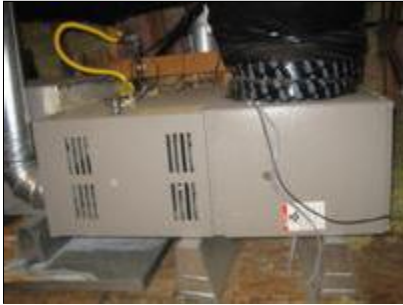
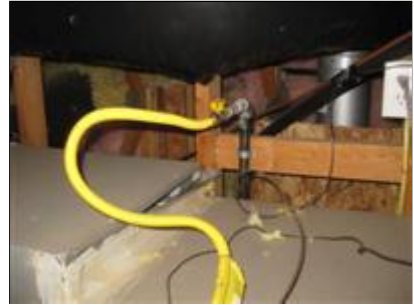
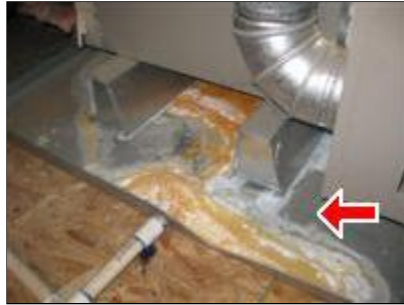
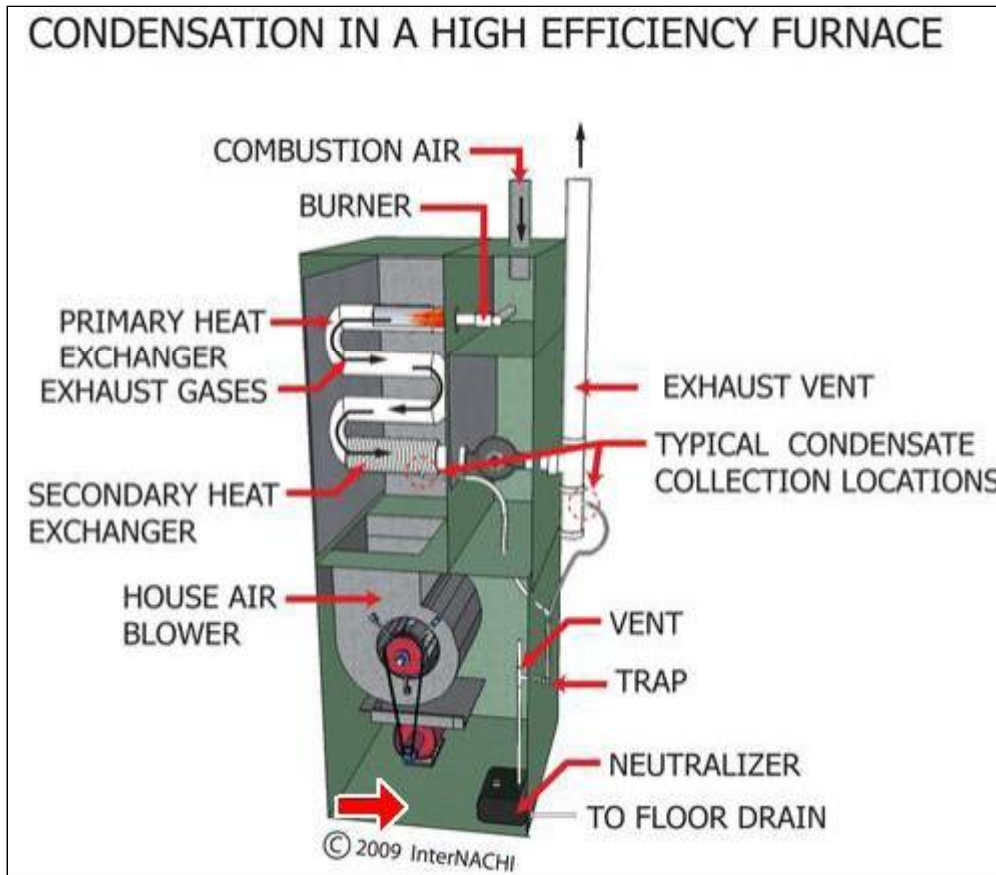
🏠 (3) P4 rusting at the drain pan under the furnace in the attic indicates that the condensation line may have been clogged and a service technician should inspect the line and clean any debris from it prior to operation of the AC unit.

(1) We recommend the the furnace be cleaned annually.

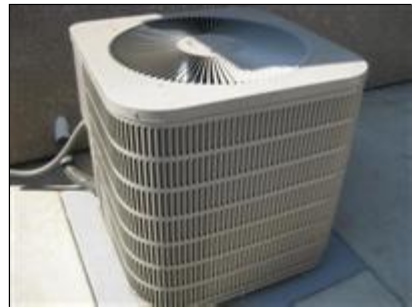
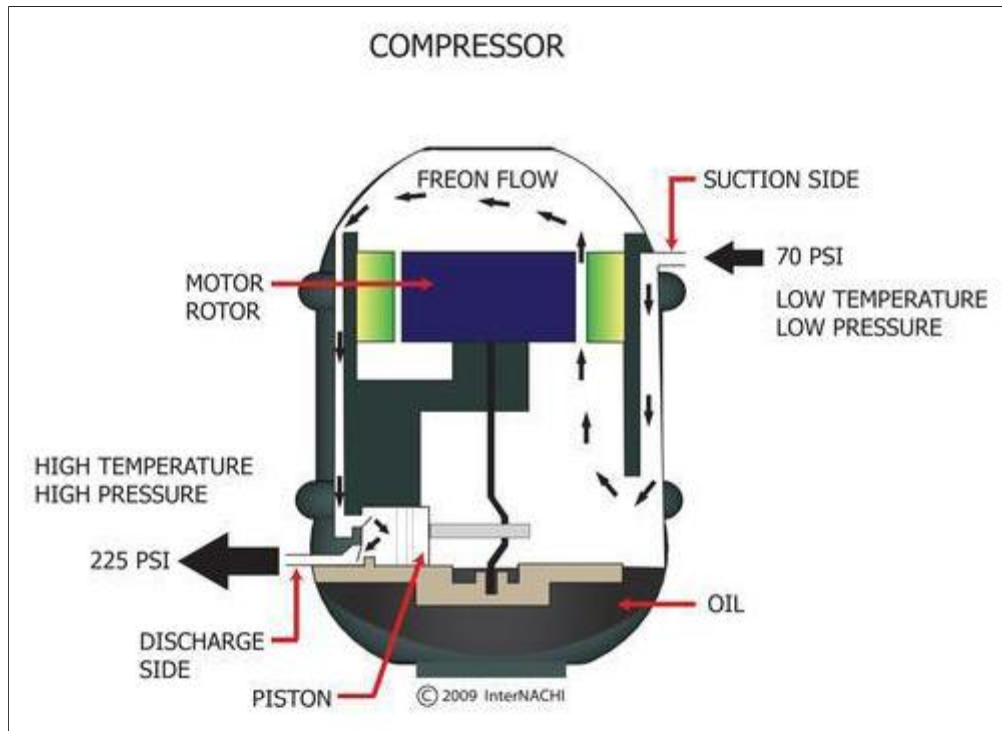
P1 The electrical service shut off is missing the interior protective panel. The missing panel should be re-installed to prevent accidental electrocution.

Ambient air test was performed by using thermometers on air handler of Air conditioner to determine if the difference in temperatures of the supply and return air are between 14 degrees and 22 degrees which indicates unit is cooling as intended. The supply air temperature on your system read 81 degrees, and the return air temperature was 78 degrees. This indicates that the unit is not working properly in cooling the home.

COMPRESSOR SHORT CYCLES - A suspected compressor defect. A qualified air conditioning contractor should be contacted to evaluate the air-conditioning system and determine the corrective measures needed.

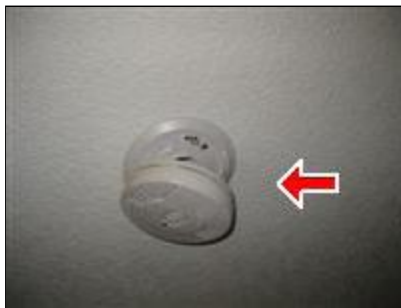
11.15 Picture 1

Smoke detectors batteries should all be replaced at the time of move in.

I highly recommend adding a combination smoke/carbon monoxide detector to the garage area, and the room near the garage.
